# Manhole Inspection Summary

Manhole # S39YY\_009MH

Insp Date: **12/14/06 8:04 AM**

**Location** Address: **3301 WESTWALDEM AVE**

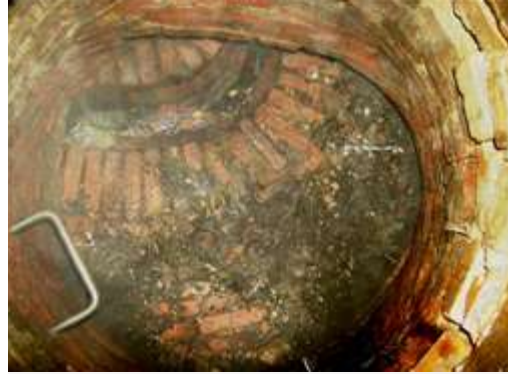
Top View

Evidence of surcharge - Bench debris.  
Channel debris.

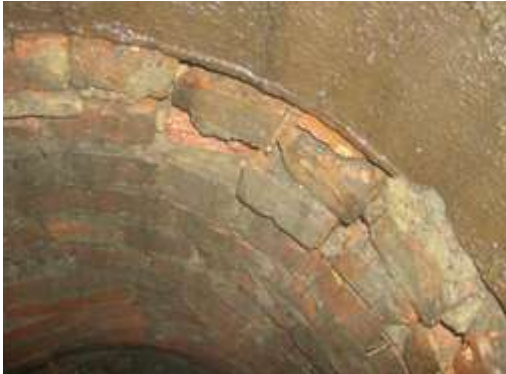
Defect

☒ **Leaks**

Condition: ☐ Sound ☐ Cracked ☐ Root Intrusion ☒ **Loose Brick** ☒ **Deteriorated**

Infiltration: ☐ None ☒ **Joint** ☐ Cracks ☒ **Mortar** ☐ Roots ☐ Wall

Infiltration: ☐ None ☐ Joint ☐ Cracks ☒ **Mortar** ☐ Roots ☒ **Wall**

Frame leaks. Adjustment deterioration,  
loose brick and infiltration. Corbel  
infiltration.

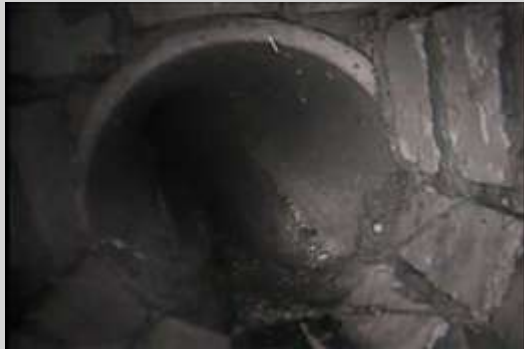
### 8 in. Circular Gravity Sewer Pipe Out @ 12 O'Clock

Deposits: ☐ None ☒ **Mud** ☐ Sludge ☐ **Debris** ☐ Grease

Infiltration: **None** Pipe Seal Cond: **Roots**

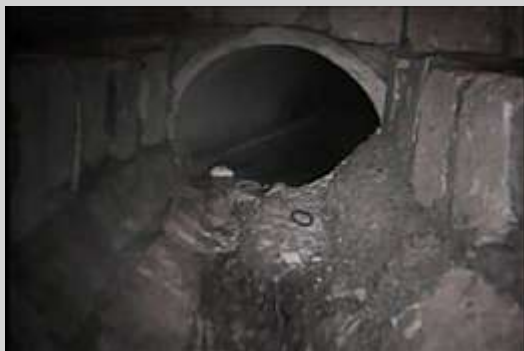
### 8 in. Circular Gravity Sewer Pipe In @ 9 O'Clock

Channel root intrusion.

Deposits: ☐ None ☒ **Mud** ☐ Sludge ☒ **Debris** ☐ Grease

Infiltration: **None** Pipe Seal Cond: **Broken**
